Federal Pacific Electric Company (FPE).

One of the most common manufacturers of circuit breaker panels in North America from the 1950s to the 1980s

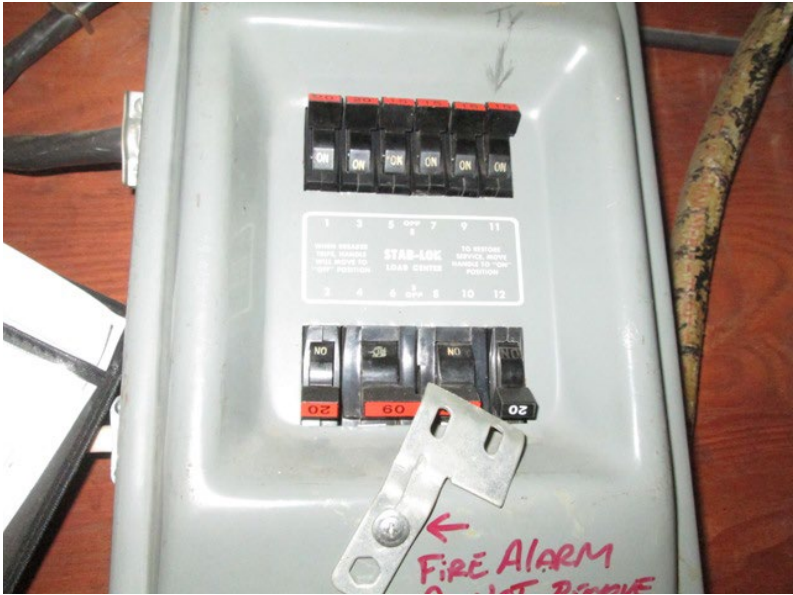
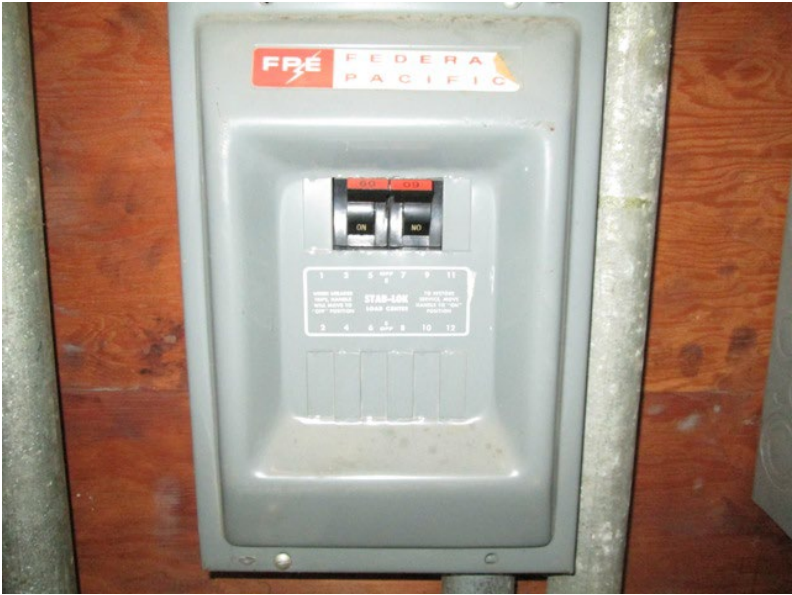
Federal Pacific Circuit Breaker panels marked Stab Lok. These panels can fail to trip in the event of over current.

- ❑ Circuit breaker panels marked stab-loc:
 - **Critical Repair** five - panels or less
 - **Non-Critical Repair** - six panels or more (due to the complexity of the job)

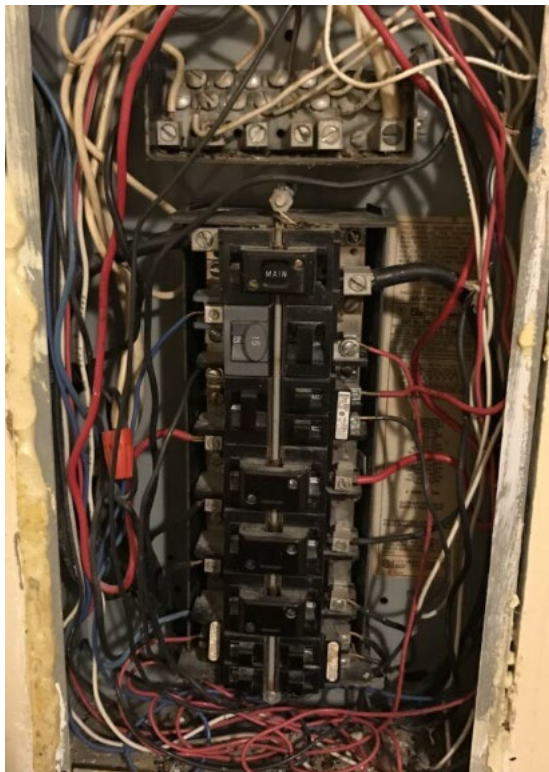
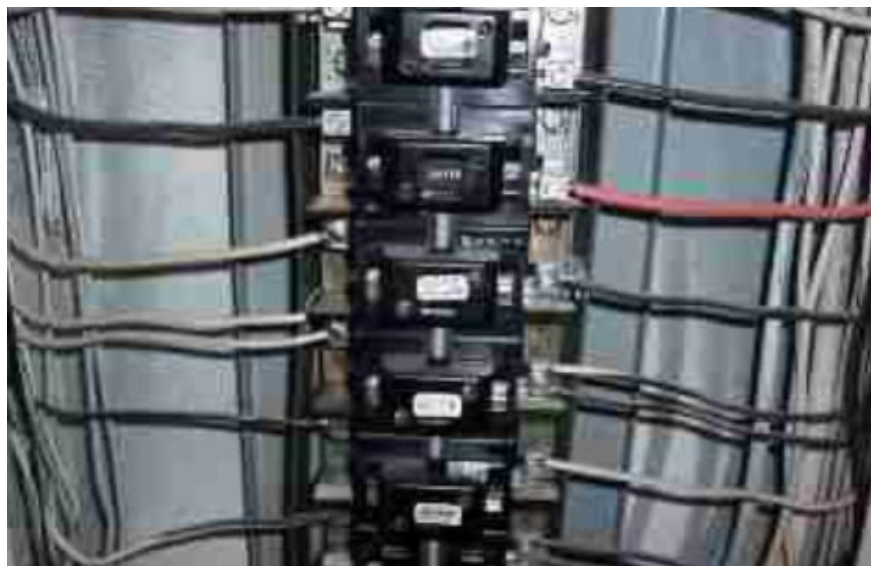
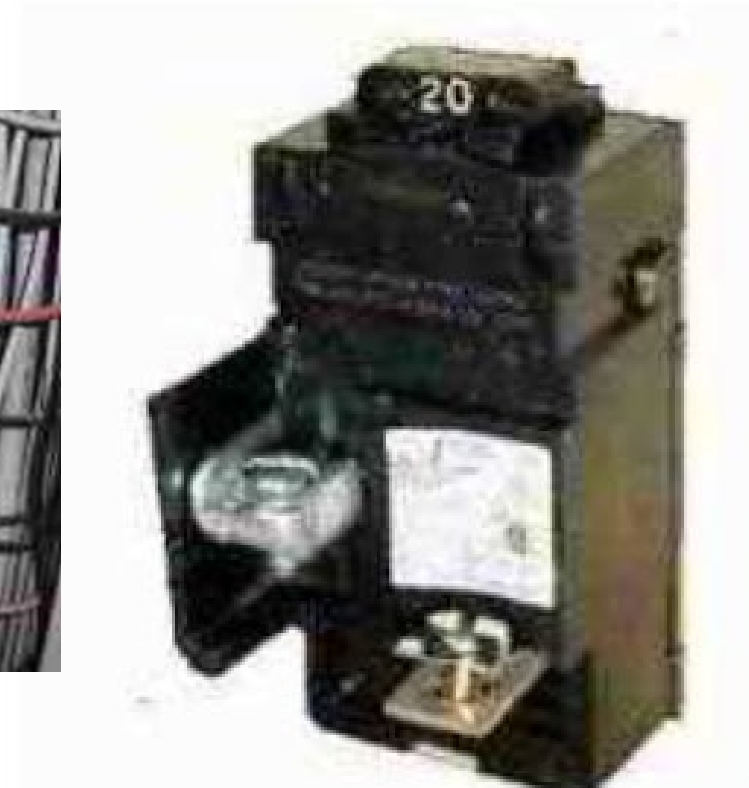
Bulldog and ITE

Bulldog Circuit Breakers have been reported to have failures when tripping. The circuit breaker's lack of a magnetic tripping mechanism seemed to be one of the reasons for breakers to fail.

□ **Circuit breaker panels** recommend replacement:

- **Critical Repair** - five panels or less
- **Non-Critical Repair** - six panels or more

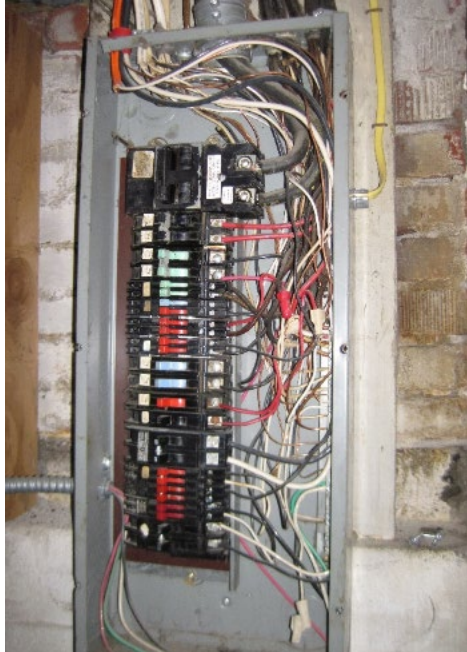
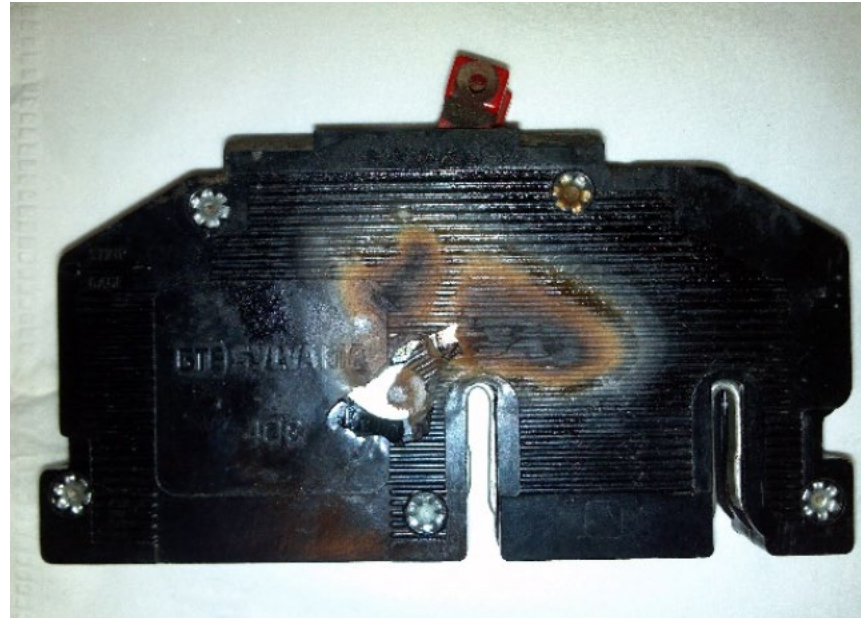
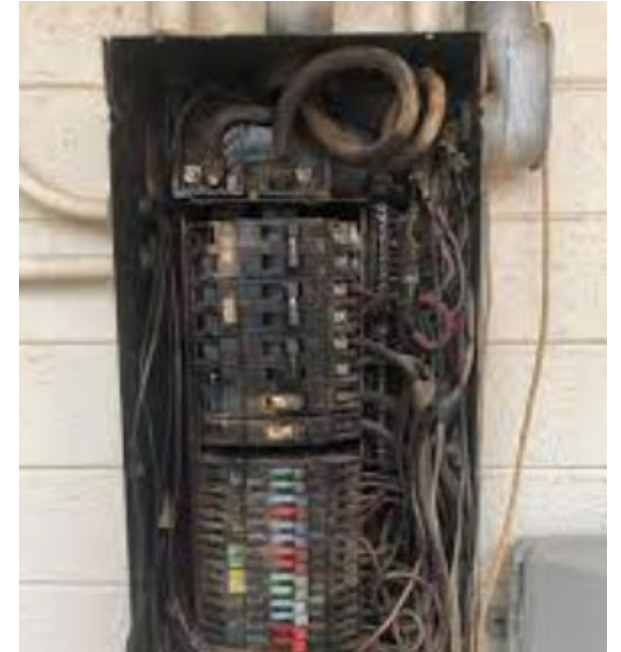
Zinsco brand no longer exists, the company's electrical panels were used in many households between the 1950s and the 1970s. *Zinsco* circuit breakers would sometimes melt to the bus bar, preventing the breaker from tripping during power shorts or surges. Melting wires inside these devices posed an even greater risk for fires and electrocutions. The *Zinsco* brand was eventually folded into *GTE-Sylvania*, so if we find a panel labeled *Zinsco*, *GTE-Sylvania*.

❑ **Circuit breaker** panels recommend replacement:

- **Critical Repair** five - panels or less
- **Non-Critical Repair** - six panels or more

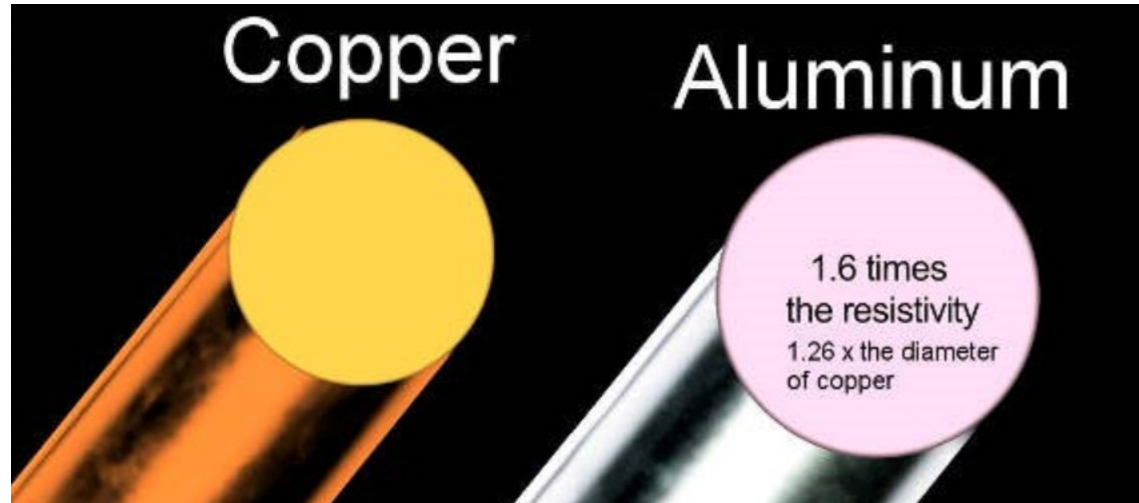
ALUMINUM BRANCH WIRING

Compared with copper, aluminum has a higher electrical resistance. For the same amount of current to flow through aluminum wire, larger wires are needed and these wires will generate more heat due to the resistance. Excessive heat can lead to warping of the aluminum wire and melting of the insulations, creating a potential fire hazard. When heated, aluminum expands much more than copper does. This extra expansion and contraction gradually causes loose connection points. In a loose connection, the wire is exposed to air. Exposed wiring is susceptible to oxidation and corrosion, which can further impede electrical flow to outlets, leading again to excessive heat.

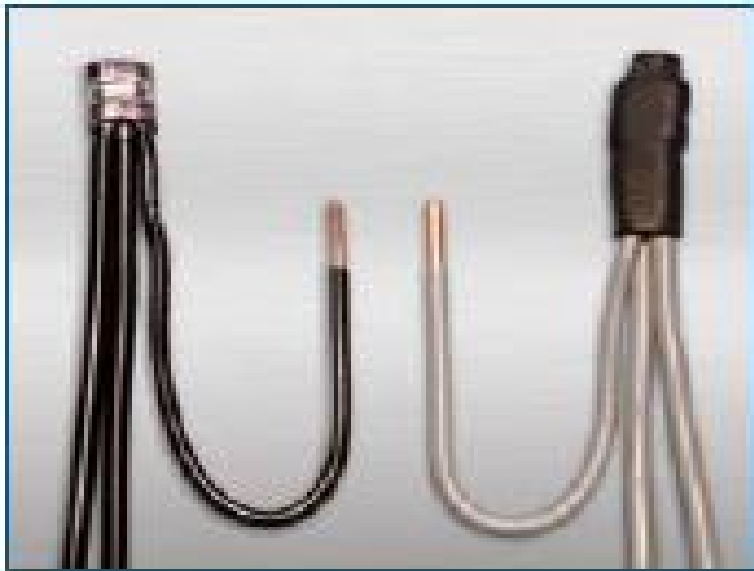
COPALUM Crimp Connector

Cost is approx. \$600-\$800/unit

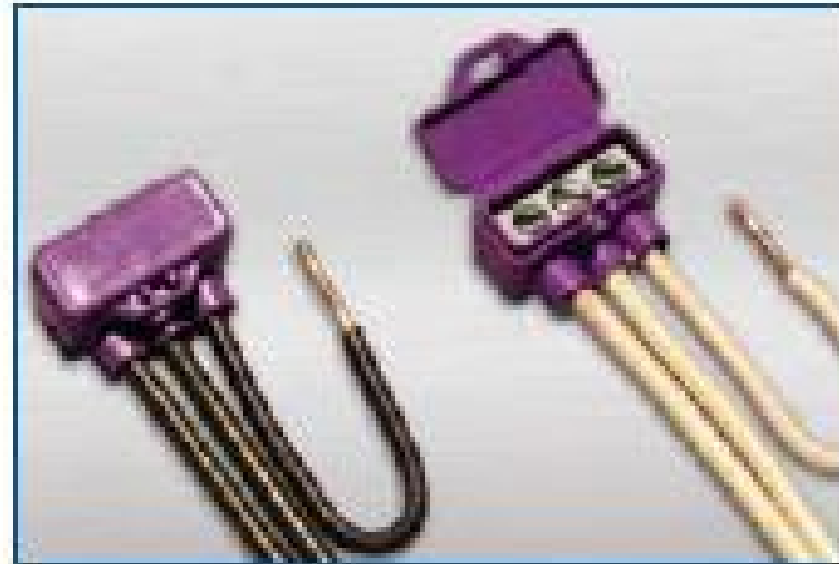
AlumiConn Connector

Cost is approx. \$200-\$250/unit

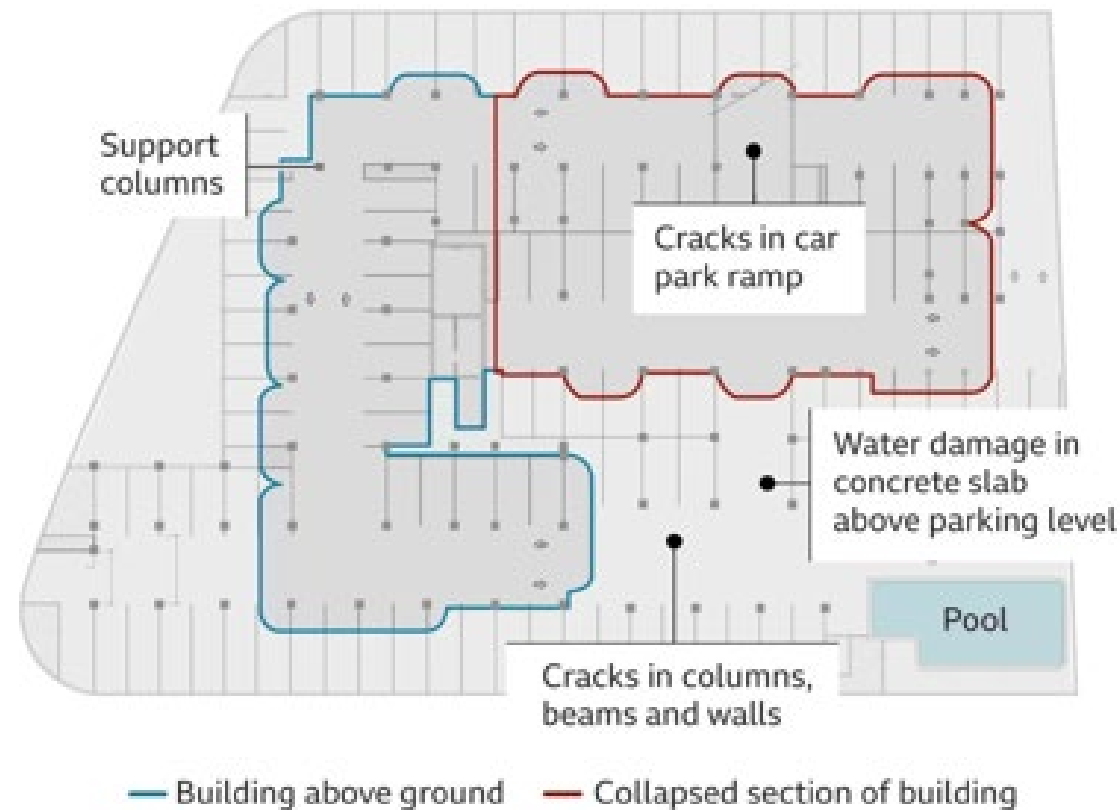
The 40-year structural Survey identified the following problems in the below-ground parking area.

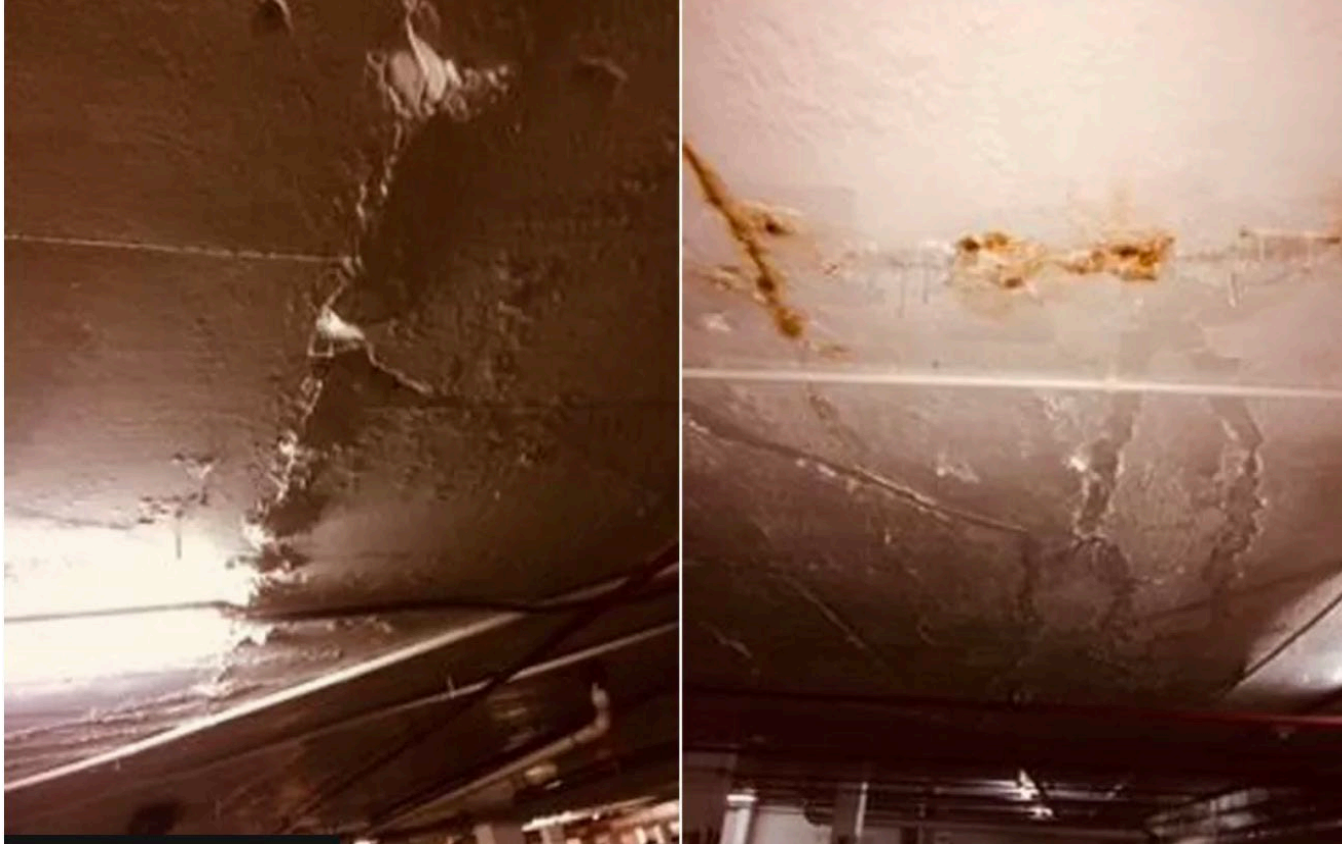
Photos from the 40-year structural report.

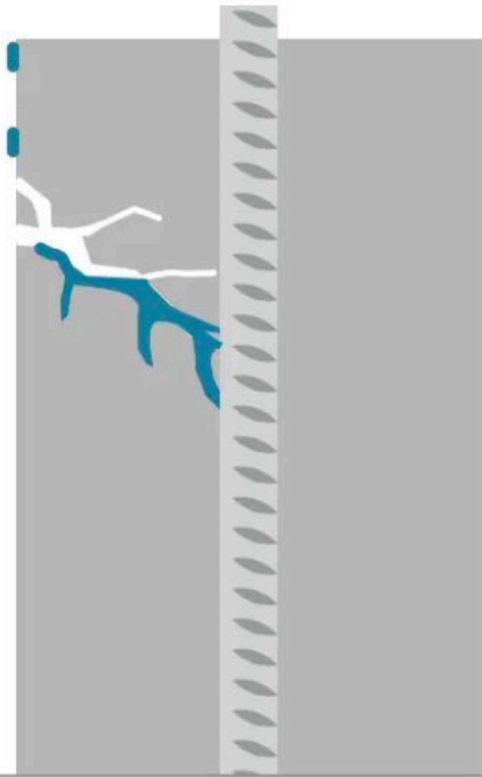
Water gets into concrete

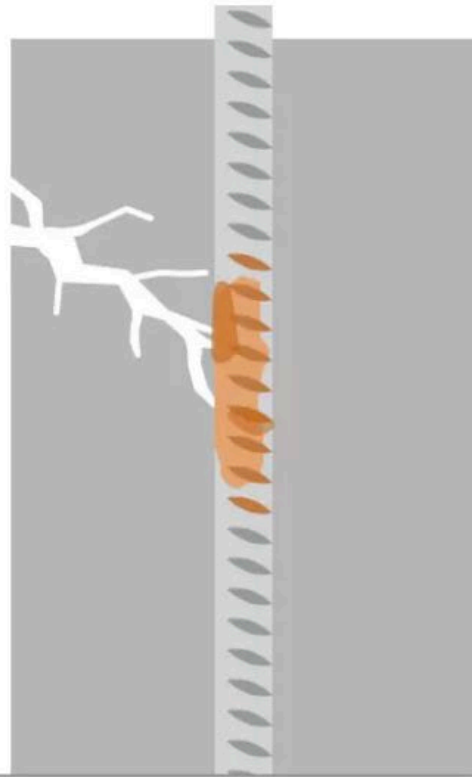
Reinforced steel rusts and corrosion builds up

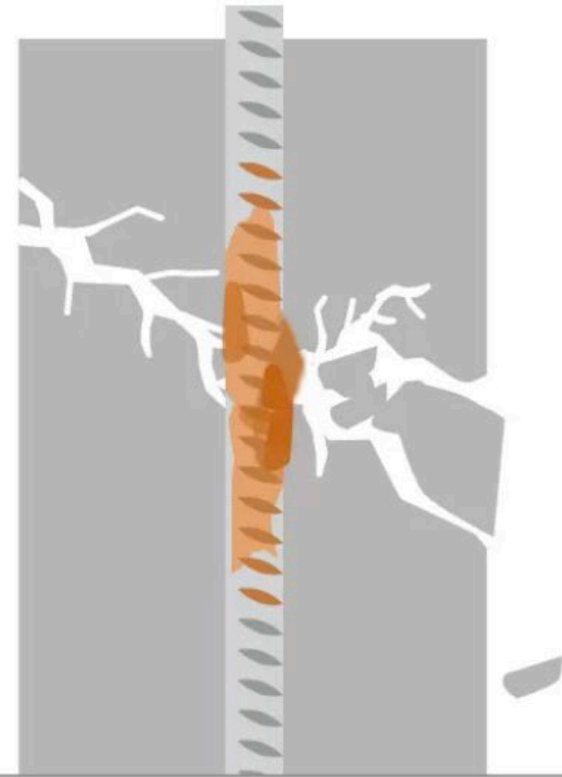
Pressure causes concrete to crack and spall (break away)
